NSTAR Extended Life Test Discharge Chamber Flake Analyses

Kim K. de Groh and Bruce A. Banks
Glenn Research Center, Cleveland, Ohio

Prepared for the
40th Joint Propulsion Conference and Exhibit
cosponsored by AIAA, ASME, SAE, and ASEE
Fort Lauderdale, Florida, July 11-14, 2004

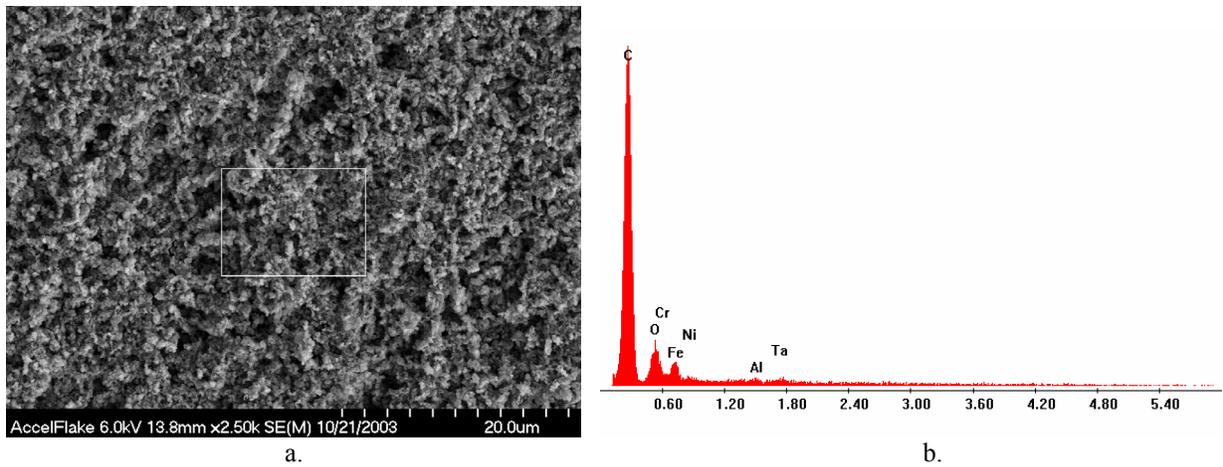
The downstream accelerator grid flakes are black in appearance and the surfaces are very porous and rough, as shown in the FESEM image shown in Figure 27a. The corresponding EDS spectrum for the box area in the center of the image in 27a is provided in Figure 27b. As can be seen the downstream accelerator grid surface is composed primarily of C (75.0 AT%), and O (9.9 AT%), with stainless steel components (6.0 AT% Fe and 7.4 AT% chromium (Cr)) and less than 1 AT% of Ni, Al, and Ta. The Ta may be a result of thruster materials depositing on the facility walls, which was further ion sputtered and re-deposited back onto the accelerator grid.

Figure 27. Downstream accelerator grid flake particle: a). Electron image of the surface of the flake, and b). Corresponding EDS spectrum (10-21-03 S2).

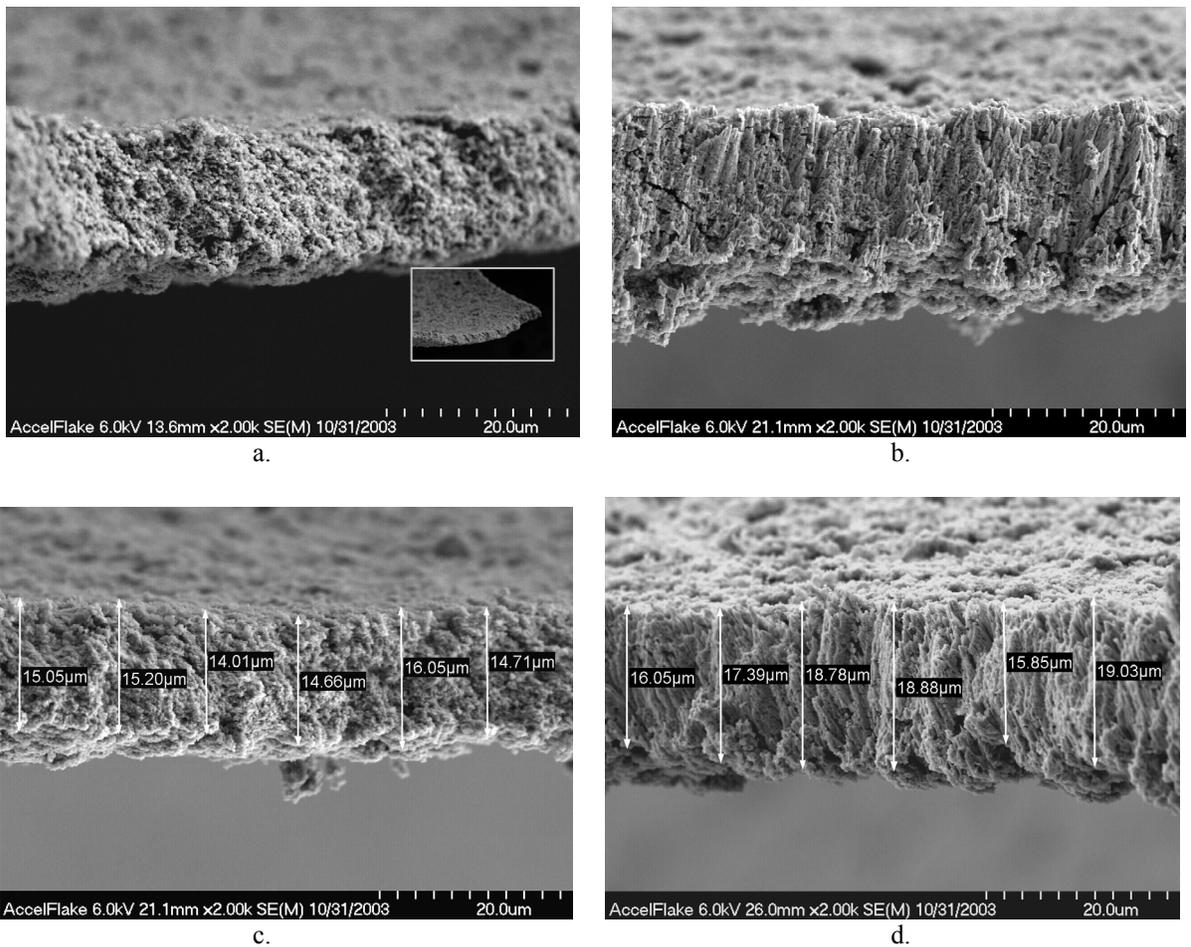
The downstream accelerator grid flakes do not have distinct separate layers like the majority of the DC flakes, but appear as a single layer flake. Images of the edges of 2 different flakes are shown in Figure 28 along with thickness markers on 2 of the images. The edges have two types of appearances; they either look similar to the surface (very porous) or they appear to have a linear sheared fracture surface. Four particles were imaged and the thicknesses at 20 different edge locations were measured. The average thickness of the downstream accelerator grid flakes was found to be 16.9 μm . This is similar to the C-rich single layer DC flake (B2 P12) that was found to be 14.4 μm thick.

Figure 28. Edge morphologies for downstream accelerator grid flake particles: a). rough edge, b). sheared edge, c). rough edge with thickness measurements, and d). sheared edge with thickness measurements.

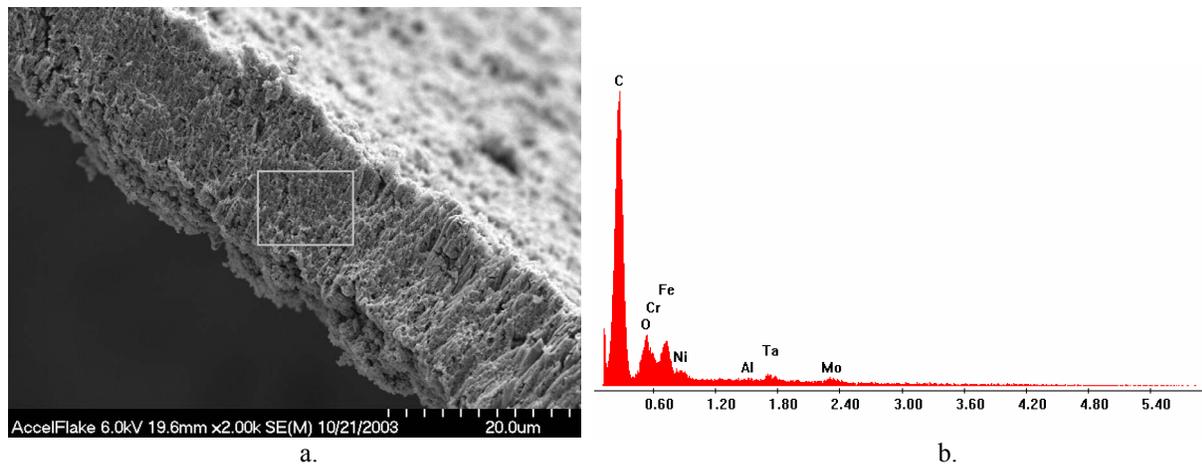
surface was composed primarily of C (62.0 AT%), with O (8.5 AT % O), stainless steel components (11.7 AT% Fe, 13.5 AT% Cr, and 2.0 AT% Ni), Mo (1.2 AT%) and less than 1 AT% of Ta and Al. This edge area had less C and more stainless steel components than the surface provided in Figure 27a and also had a small amount of Mo (1.2 AT%).

Figure 29. Edge morphology and corresponding chemistry of a downstream accelerator grid flake particle: a). Electron image of edge of flake, and b). Corresponding EDS spectrum (10-21-03 S3) obtained at the box shown in a).

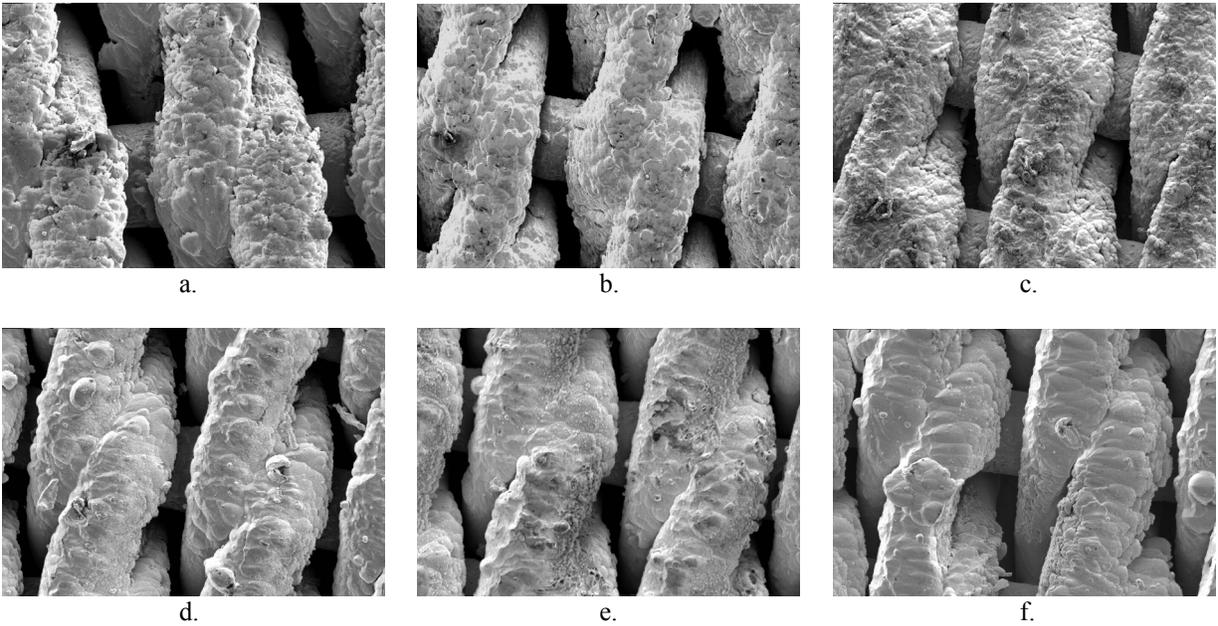
GRC analyzed samples of the thruster's containment mesh. As mentioned previously, the purpose of the analysis was to determine if the grit-blasted sputter containment mesh functioned properly in retaining the coating deposited on it during the length of the run rather than allowing it to spall off into the chamber, possibly being the source of the DC flakes. The FESEM images of the containment mesh clearly showed that there is a coating deposited on the surface of the containment mesh and that the thickness of this coating increases from the cathode to the grid optics. Figure 30 provides electron images of one of the axial sets of containment mesh samples obtained at the same magnification for comparison. The samples shown in Figure 30a to 30f include Samples 3, 4, 5, 30, 31, and 32, respectively. Sample 3 was located in the conical area closest to the cathode. Sample 4 was located in the center of the conical area. Sample 5 was located in the conical area near the edge of the conical/cylindrical intersection region. Sample 30 was located in the cylindrical section near the conical/cylindrical intersection region. Sample 31 was located in the center of the cylindrical section, and Sample 32 was located in the cylindrical region closest to the grids. The coating on Sample 3 appears the thinnest and the coating on Sample 32 appears to be the thickest.

The chemistry of the coating on the anode mesh was determined at GRC by EDS to be mostly Mo with small amounts of the components of stainless steel (Fe, Cr, Ni). No spalling is evident, even from the samples of containment mesh cut from the region closest to the optics, which had the thickest coating of all the regions. One set of mesh samples (Samples 21-26) were purposely scratched in an effort to induce spalling, even after being physically scraped the coating on the anode mesh samples did not show signs of spalling or lifting off. This provides evidence that the DC flakes did not originate from spalling of the containment mesh coating.

Figure 30. Anode mesh samples section in a radially similar position from within the DC: a). Sample 3, located in the conical region closest to the cathode, b) Sample 4, c). Sample 5, d). Sample 30, e). Sample 31 and f). Sample 32, located in the cylindrical region closest to the grids.

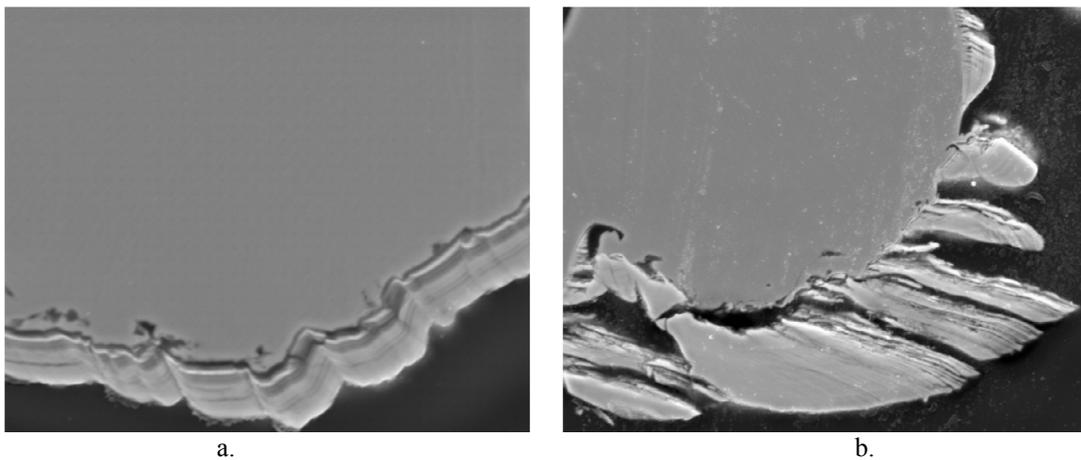
Two of the samples (Sample 21 and Sample 26) were sent to the University of Dayton Research Institute for additional analytical analysis. The mesh samples were cross-sectioned and potted, and the chemistry of the coating was determined using EDS. Figures 31a and 31b provide electron images of cross-sectioned Sample 21 and 26, respectively (Sample 21 was imaged at 1.5X higher magnification than Sample 26). The coating on Sample 21, which was closest to the cathode, was much thinner than on Sample 26 (closest to the grids) and it was found to be comprised of 65.0 AT% C, 14.8 AT% Mo, 10.9 AT% O, 3.3 AT% Fe, 2.6 AT% Xe, and 1.6 AT% Si (Si and Ta reside at the same peak location). The coating on Sample 26 was found to be thick and was comprised of 49.3 AT% C, 40.1 AT% Mo, 10.0 AT% O and 0.7 AT% Ta. It should be noted that these EDS data were obtained at 20 kV, which can excite Xe, whereas 6 kV does not.

Figure 31. Electron microscope images of cross-sectioned anode mesh samples: a). Sample 21 located closest to the cathode, and b). Sample 26 located closest to the screen grid.

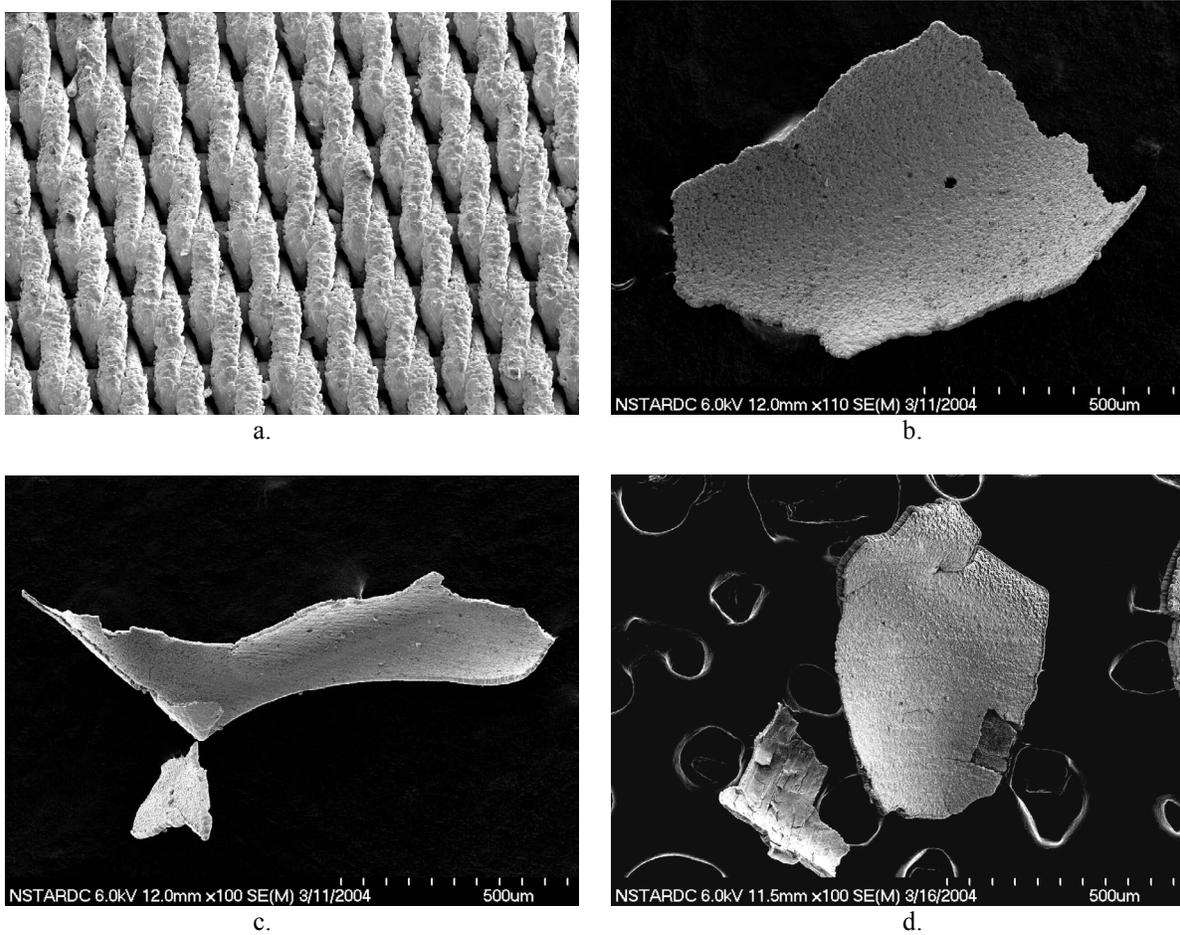
As another verification to show that the DC flakes did not originate from the containment mesh, electron images of several larger DC flakes have been compared with the anode mesh texture at approximately the same magnification, as shown in Figure 32. As can be seen by comparing these images, the DC flake particles do not replicate the woven texture of the anode mesh. The flakes are comparatively much smoother than the anode mesh texture and appear to have spalled off of a flat or curved smooth surface. Another comparison can be made between the anode mesh image and the largest DC flake (B3 P1) shown in Figure 24a.

Figure 32. Comparison of the macro texture of the coated sputter containment mesh and DC flakes: a). Sputter containment mesh (Sample 21), b). DC Flake B4 P3, c). DC Flake B4 P1, and d). Flake B2 P6.
